DESIGN AND FABRICATION OF A BORON ALUMINUM COMPOSITE WING BOX TEST SPECIMEN

FINAL REPORT

July 73

Convair Aerospace Division

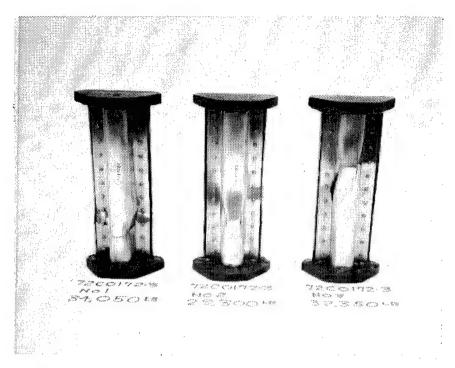
Figure 3.5. Failed Riveted Crippling Specimen Showing Fracture of the Boron Aluminum Stringer (Neg. 126984B)

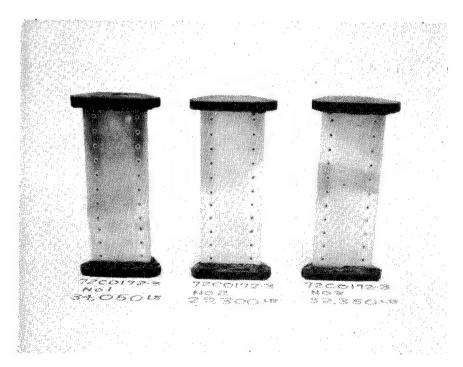
Figure 3.6. Failed Rivet Crippling Specimen Skin Side (Neg. 126986B)

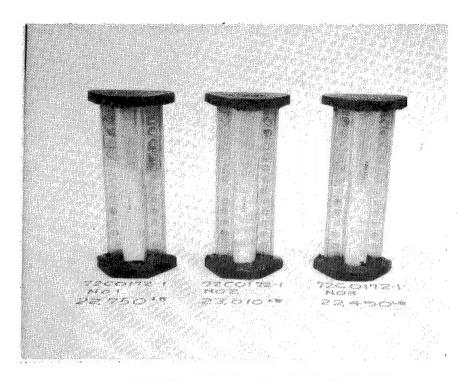
Figure 3.7. Failed Spotwelded Crippling Specimens Showing Classical Buckling of Stringer Elements. (Neg. 126985B)

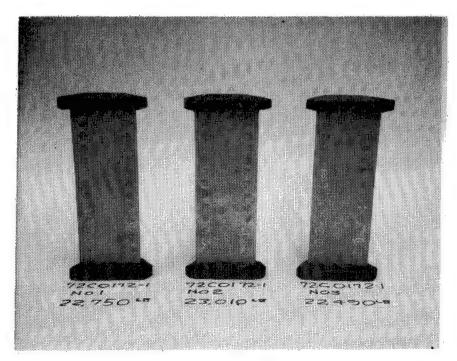
Figure 3.8. Failed Spotwelded Crippling Specimens Skin Side (Neg. 126987B)

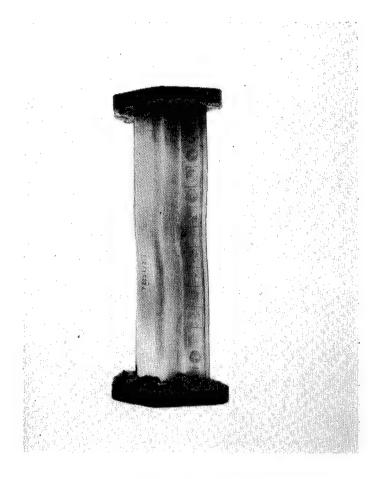
Figure 3.9 shows clearly the buckled hat section with no fractures evident.

Figure 3.9. Spotwelded Crippling Specimen Showing Buckles in all Elements of the Hat and Skin. (Neg. 126988B)

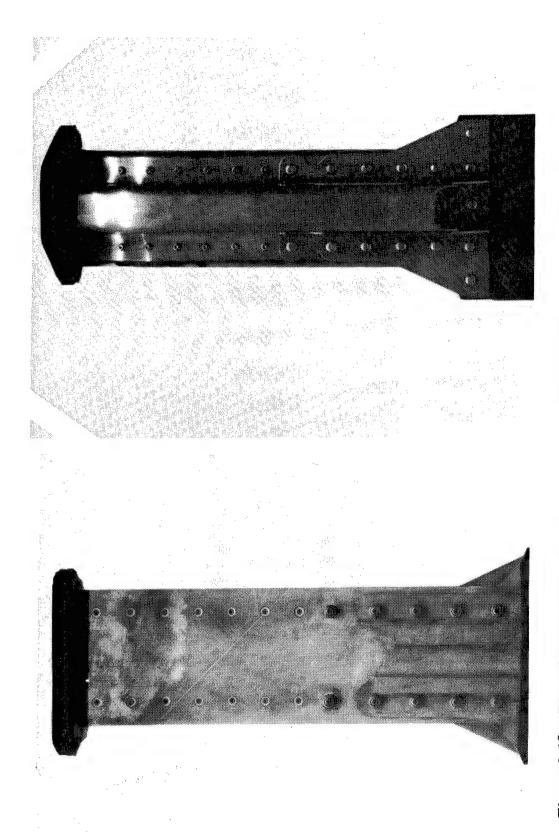
The compression specimens failed at 21,640 pounds for the riveted specimens (Figures 3.13 and 3.14) and 17,690 pounds for the spotwelded specimens (Figures 3.15 and 3.16). Failure on both specimens consisted of crippling of the skin and stringer away from the loads introduction area. The maximum required compression load was 13,880 pounds. Both of the specimens easily surpassed the required loading.

Figure 3.13. Riveted Compression Load Introduction Fitting after Testing.

Figure 3.14. Riveted Compression Load Introduction Fitting. The buckle is apparent near the top of the hat just below the end potting.

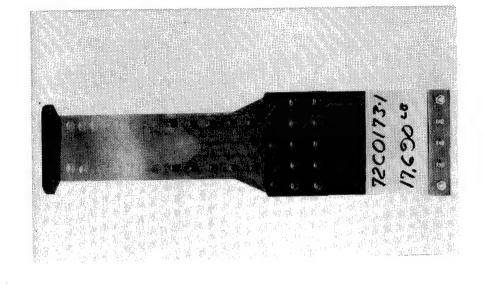
Figure 3.16. Stringer Side of Failed Spotwelded Compression Fitting.

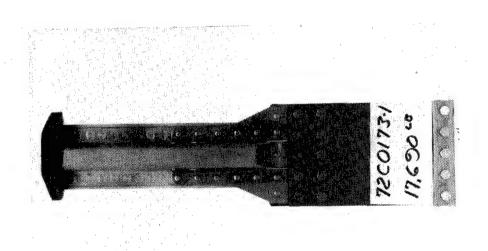
Figure 3.15. Spotwelded Compression Load Introduction Fitting after Testing.

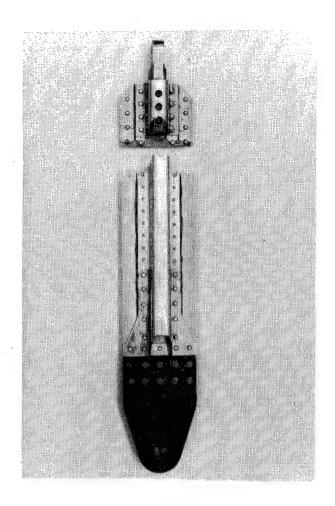
The failure occurred at the end of the stringer load introduction fitting (Figure 3.17). It is obvious that more care is needed to be taken in the design of the test joint. A better test could have been achieved by using a double joint typical of the composite to steel end of the specimen.

Figure 3.17. Failed Stringer Joint Specimen.

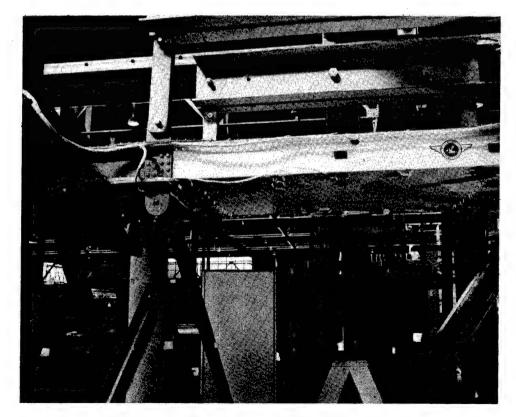
5.3.1 PURE BENDING TESTS. The wing box was subjected to bending loads to 120 percent of limit and to 150 percent of limit without failure. The compression skin buckled visibly above 80 percent limit load.

The unloaded wing box is shown in Figure 5.8. The compression skin is shown to be smooth and free of distortion. Figure 5.9 shows the wing at 120 percent limit load in bending. The skin buckles are apparent in all three bays. Figure 5.10 is a plot of 3 compression strain gages during the first bending test to 120 percent limit. The loading was interrupted after the initial 110 percent loading. The second group of curves between 100 and 120 percent limit represent the strain when the test was resumed.

Figure 5.9. Buckles in Wing Compression Skin Due to Pure Bending.

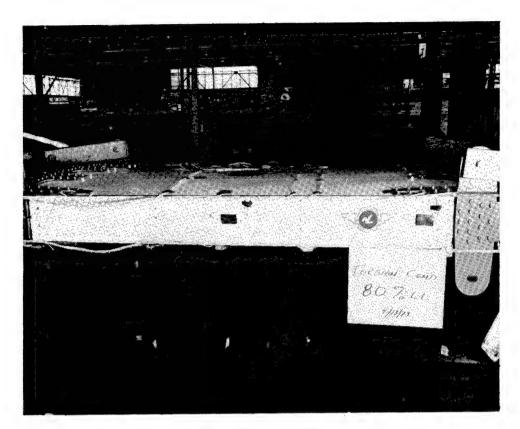
- 5.3.2 TORSION TESTING. The wing box was tested in torsion in two series of tests. The first to 120 percent of limit and the second to 150 percent of limit load. Figures 5.13 through 5.15 show the progression of diagonal tension wrinkles on the lower skin of the wing box as it was loaded to 120 percent LL. The buckles did not grow in amplitude appreciably as the load intensity increased. Figures 5.16 and 5.17 show the strain reading on the top and bottom skin during the initial loading cycle. Figure 5.18 shows a comparison of the strain readings between the 110 percent LL series and the 150 percent LL series of tests. The wing box was usually inspected after the testing and no evidence of failure or damage was evident.

Figure 5.13. Wing Box at 80% L.L. in Torsion.

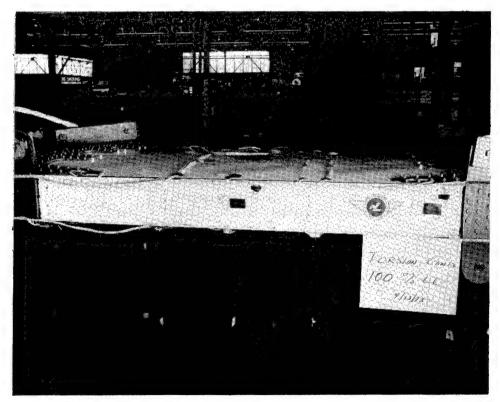
Figure 5.14. Wing Box at 100% L.L. in Torsion.

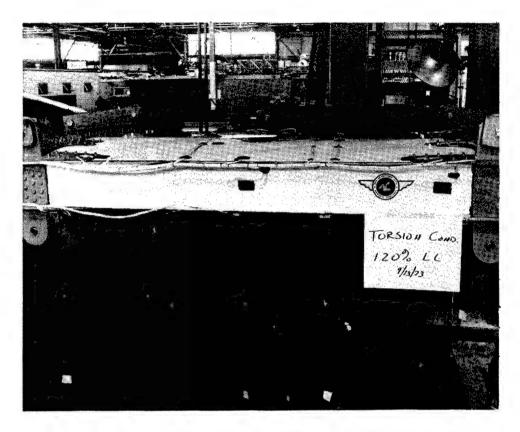
Figure 5.15. Wing Box at 120% L.L. in Pure Torsion

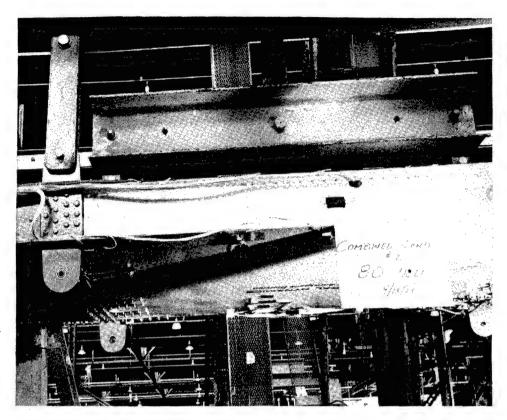
As indicated in Section 2.2.1 the torsion load which combines with the bending moment is much smaller than the pure torsion mode. The two series of tests were performed and no failure or distress of the wing box was apparent. Figures 5.19 to 5.22 are a series of photographs showing the compression skin buckles from 80 percent LL to 150 percent LL. No damage was evident after this testing.

Figure 5.19. Compression Skin Buckles at $80\%\,\mathrm{L.L.}$

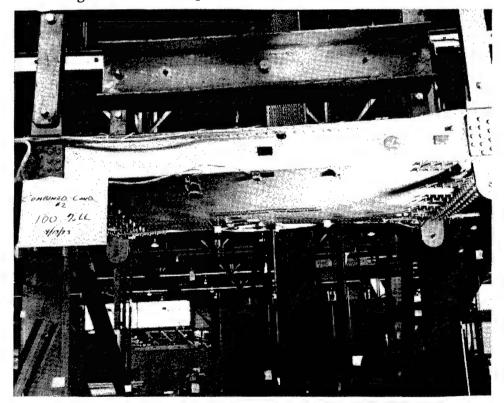
Figure 5.20. Compression Skin Buckles at 100% L.L.

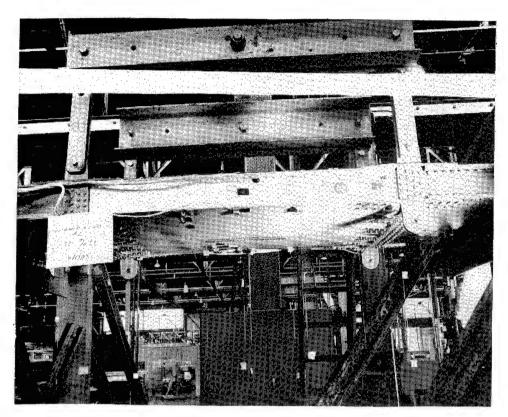
Figure 5.21. Wing at 130 Percent Limit Load Combined Loading Case

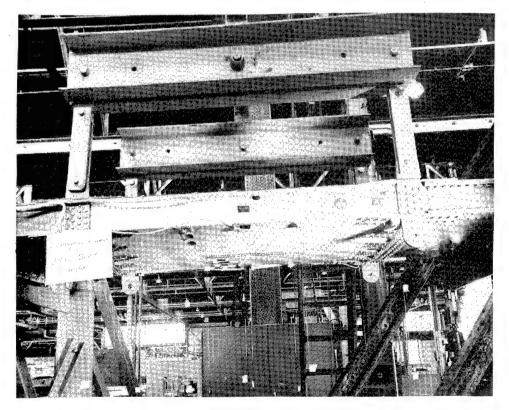
Figure 5.22. Wing at 150 Percent L.L. Combined Load Case

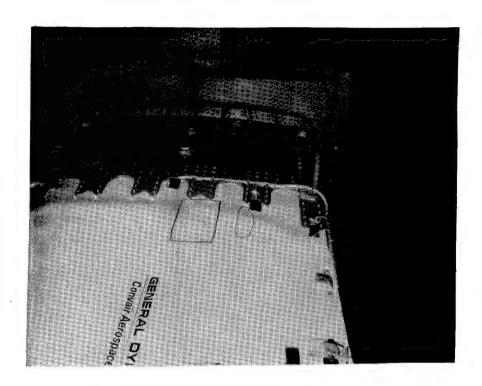
loading condition. Failure was observed during Block 1580 (31,600 hours) which is over five lifetimes. Failure occurred as buckling of the compression surface and subsequent inter-rivet cracking along two stringers as shown in Figures 5.23 and 5.24.

Removal of the inspection door permitted the interior of the wing to be inspected and revealed that the cause of the buckle was the fatigue failure of several of the stringers along the radius between the skin flange on the side of the hat (Figure 5.25). This condition allowed the skin and skin flange to buckle independently from the remainder of the stiffener. The skin had also cracked along the rivet rows in some places. All these fatigue cracks were due to the flexure in the skin flanges of the stringers. These areas were not instrumented so the magnitude of the buckling strain is not available.

Figure 5.23. Buckle in Compression Skin After Fatigue Testing.

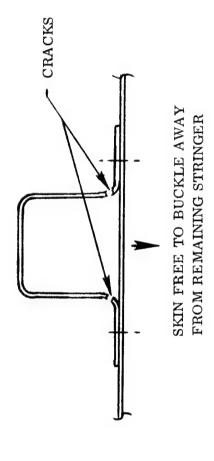
Figure 5.25. Detail of Cracked Stringer.

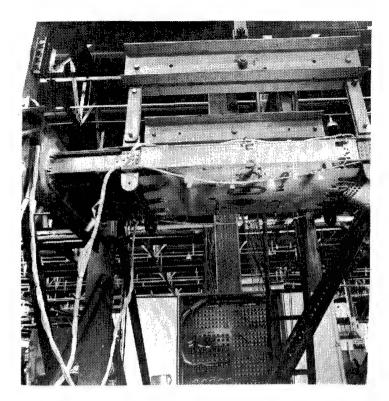
5.3.6 REVERSE BENDING. Since no damage was apparent on the tension surface, a static test was performed to compare the buckling load of the tension surface (upper skin) with the predicted buckling load. The PUL (Predicted Ultimate Load) for buckling of the upper skin was 522,000 in/lb. This is considerably higher than the design ultimate load in Paragraph 3; however, the excessive margin is attributed to a relatively cursory design effort in which three stringers were considered more than adequate to sustain the negative bending load. The wing box was inverted in the test jig so that what was previously the tension surface was now the compression surface. The loads were applied in 20% increments of design limit load. Buckling of the skin was noted at approximately 42% PUL. Loading was continued to 86% PUL at which point the load was removed to determine if any permanent set was evident in the form of skin buckles. None were apparent so the wing box was loaded slowly again to failure. Failure occurred at 93% PUL as buckling of the panel across the width of the wing box as shown in Figures 5.26 and 5.27. Examination of the stringers indicated that the vertical portions of the hat section had failed in a local mode of buckling.

When the compression skin buckled, the wing still carried the applied load even through portions of the inboard flange of the spars had buckled with the skin. It has been estimated that the remaining spar caps are carrying over 300,000 psi in this condition.

Figure 5.26. Buckle in Compression Skin After Failure in Reverse Bending.

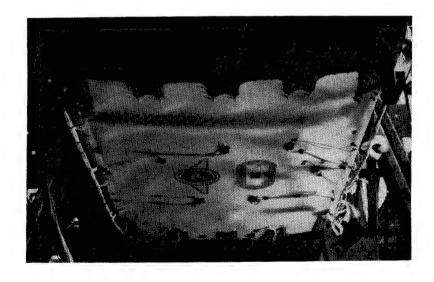
Figure 5.27. Buckle in Compression Skin Reverse Bending.
